# Thermal performance of different masonry wall composition. Case study: Polis University, Tirana, Albania.

**Abstract.** Albania is part of the emerging economies of the Western Balkan region. Polis University is one of the pioneering institutions in the field of architecture, built environment, and city sciences that represents innovative methodologies and concepts for educational and scientific purposes. Nowadays, many constructions in Albania involve a wide range of different materials. The building envelope is one of the main elements that provide protection from the outside environment but also the required thermal comfort for the inhabitants. The necessary balance must be archived between energy efficiency and the durability of buildings. This paper will focus on the thermal performance and materials composition of two different types of masonry walls, a constituent part of Polis University's main building. The study will be based on an experiment using specific instruments to diagnose these typologies of wall composition. The results are further analyzed and compared. Specific instruments such as the thermal camera (Testo 882), U-value (Testo 435-2), and "Silverline Digita

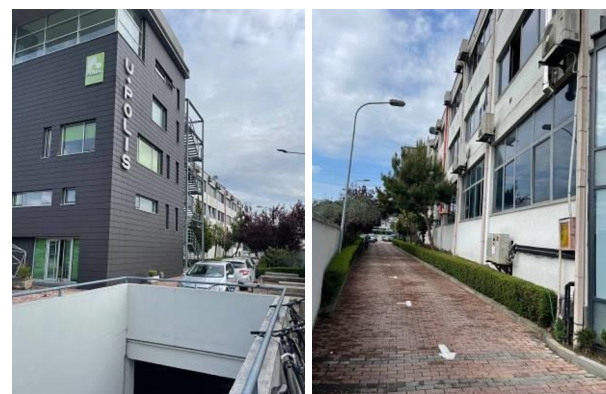
**Fig. 1.** Eastern facade of POLIS University. (Source: Authors).

This paper is going to analyze two different types of wall composition parts of POLIS University's main building. The facade has an eastern orientation as seen in Figure 3.

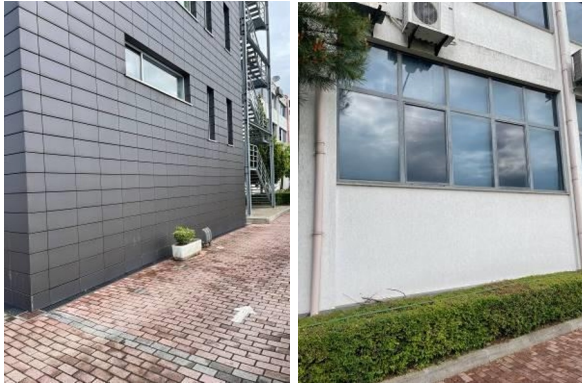
**Fig. 2.** A. Masonry wall with ventilated facade; B. Masonry wall without ventilated facade. (Source: Authors).

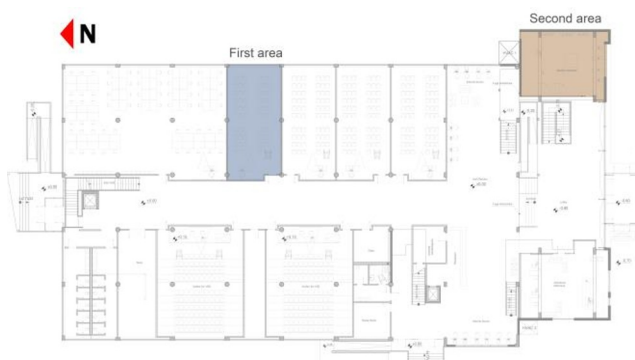
**Fig. 3.** Ground floor, POLIS University. Location of the areas of interest. (Source: Polis University).

The selected areas of the experiment are shown in Figure 3. Both of the areas are in direct contact with the eastern facade.

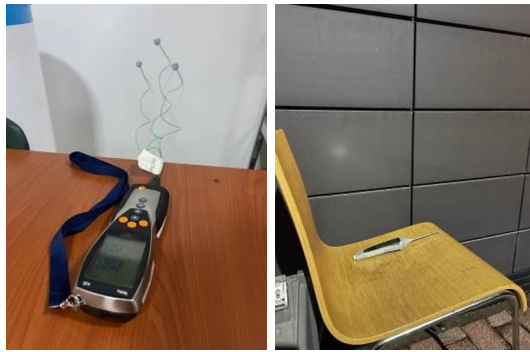
**Fig. 5.** A. Testo 435-2 during measurements; B. Outdoor Wi-Fi sensor. (Source: Authors).

Two Testo 435-2 devices are used simultaneously in both cases in order to measure the U-value coefficient. The measurement time lasted three hours. The devices were set to obtain one measurement every 30 seconds. The total number of measurements was 360. The day of measurements was 17-18/05/2023 and the time of the measurements was 11.00 PM - 2.00 AM (3 hours).

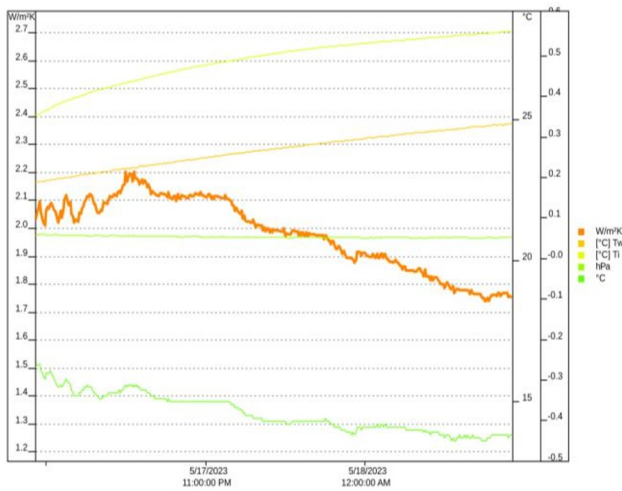
**Fig. 6.** A. Masonry wall without a ventilated façade. U-value results. (Source: Authors).

The mean temperature difference between indoor and outdoor environments was 12.5°C. The mean temperature of the internal wall surface was 23.9°C. Meanwhile, the mean U-value coefficient of the masonry wall without ventilated facade was 1.981 W/m<sup>2</sup>K as seen in Figure 6, and Table 1.

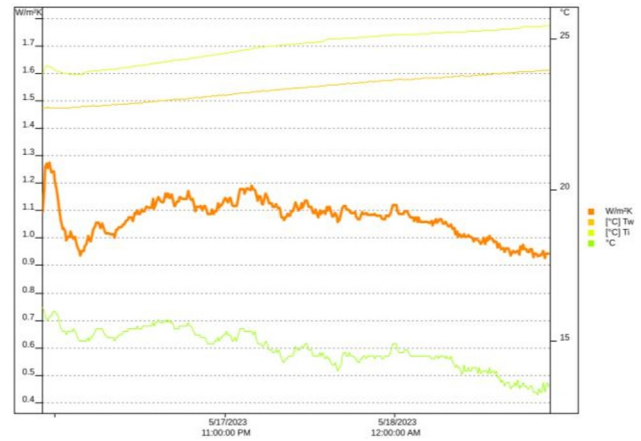
**Fig. 7.** Masonry wall with ventilated façade. U-value results. (Source: Authors).

The mean temperature difference between indoor and outdoor environments was 10°C. The mean temperature of the internal wall surface was 23.4°C. Meanwhile, the mean U-value coefficient of the masonry wall with ventilated facade was 1.072 W/m<sup>2</sup>K as seen in Figure 7, and Table 2. The U-value graph, in this case, is more linear than the previous one, and the parameter oscillation values are reduced compared to the masonry wall without a ventilated facade.

It is observed that the masonry wall without a ventilated facade has a higher U-value compared to the masonry wall with a ventilated facade, due to lack of thermal insulation air cavity, and ceramic tiles. The U-value difference between the two types of walls is 0.909 W/m<sup>2</sup>K. Obviously, the masonry wall with a ventilated facade performs better than the masonry wall without a ventilated facade. Therefore, their usage is strongly recommended to be improved for i) the masonry wall without ventilated facade in the existing building, ii) and in the reconstruction of the second new building of the University, which is in the process of improvement.

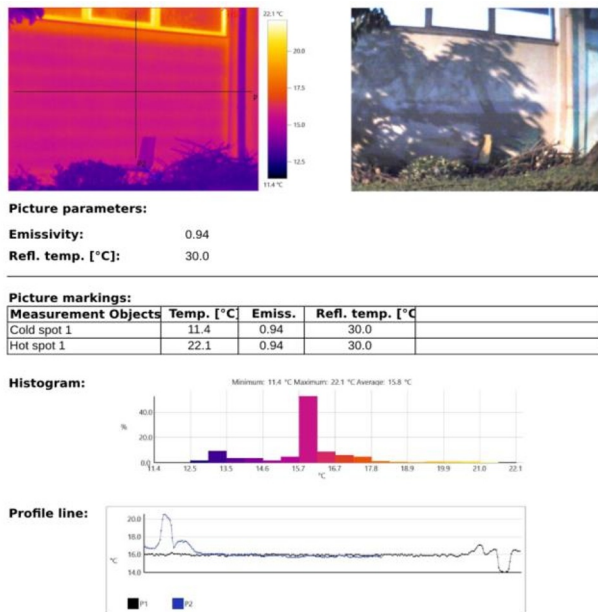
**Fig. 8.** Thermal photo of the masonry wall without ventilated facade. (Source: Authors).

It is observed that there are huge temperature differences between the masonry wall, window frames, and glass. In this case, the window is realized without a thermal cut and thermal bridges are evident. According to vertical profile line P2, where the hottest spot of the image is located (22.1°C), the difference in the temperature between the window frame and the central area of the wall is around 6°C. The mean temperature of the central masonry wall is around 16°C. Meanwhile, the coldest spot of the facade is located in the metallic vertical exhaust pipe. The horizontal profile line temperature fluctuation is almost stable. It becomes unstable just in the position of the metallic vertical exhaust pipe as seen in Figure 8.

It is observed that the average temperature of the masonry wall without a ventilated facade and the average temperature of the masonry wall with a ventilated facade are respectively 15.8°C and 11.00°C. The hot spot and cold spot are respectively 22.1 °C and 11.4 °C for the first case and 15.4°C and 4.9°C for the second case. These variations result from the absence of thermal insulation in the initial scenario and the presence of thermal bridges.

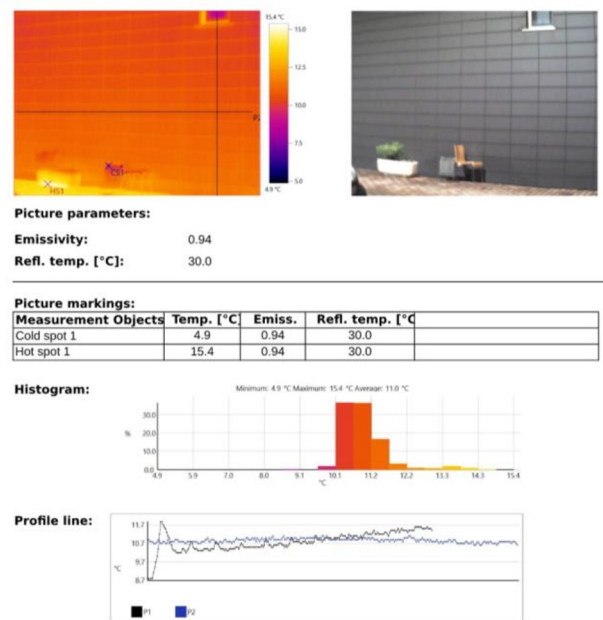
**Fig. 9.** Thermal photo of the masonry wall with ventilated facade. (Source: Authors).

It is observed that in such circumstances, the overall temperature fluctuations of the ventilated facade are lower compared to the masonry wall without a ventilated facade. According to the vertical temperature profile line in the window, are observed higher temperature oscillations compared to the central area of the facade. This is due to the glass and the metallic structure positioned in the lower part of the window. The window's metallic frame additionally serves as a potential source of thermal bridges. The mean temperature of the facade in the center area is 10-11°C, which is lower than the masonry wall facade without a ventilated facade. This is due to thermal insulation, air cavities, and ceramic tiles applied. Improvements are recommended to the existing glass and metallic structure of the facade to reduce energy loss.

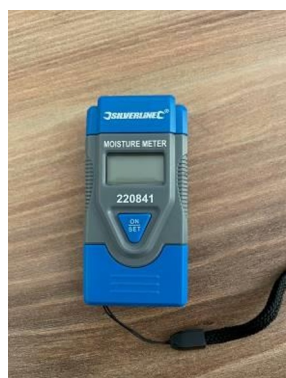
The Silverline Digital Moisture Meter is a handheld device that measures the moisture content of various materials, including wood, plaster, and masonry. The

meter works by sending an electrical signal into the material, and based on the resistance, it can determine the level of moisture present.

**Fig. 10.** Silverline Digital Moisture Meter. (Source: Authors).
